# Ridván Garden

Conservation of the historic monuments Akko

Final  
Conservation  
Report

Bahá'í World Centre  
Northern Development Projects  
April-November 2008

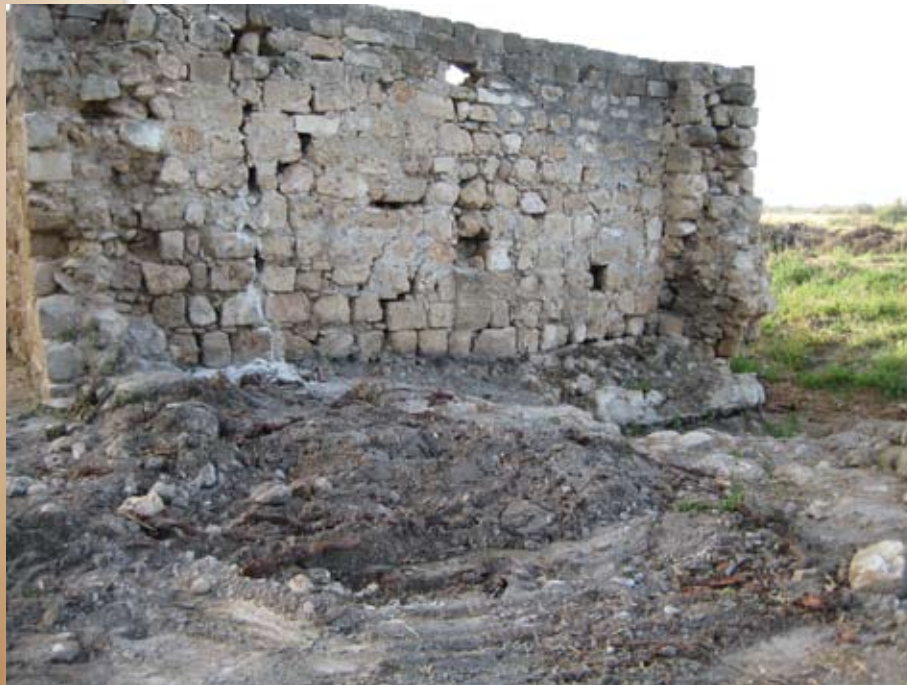
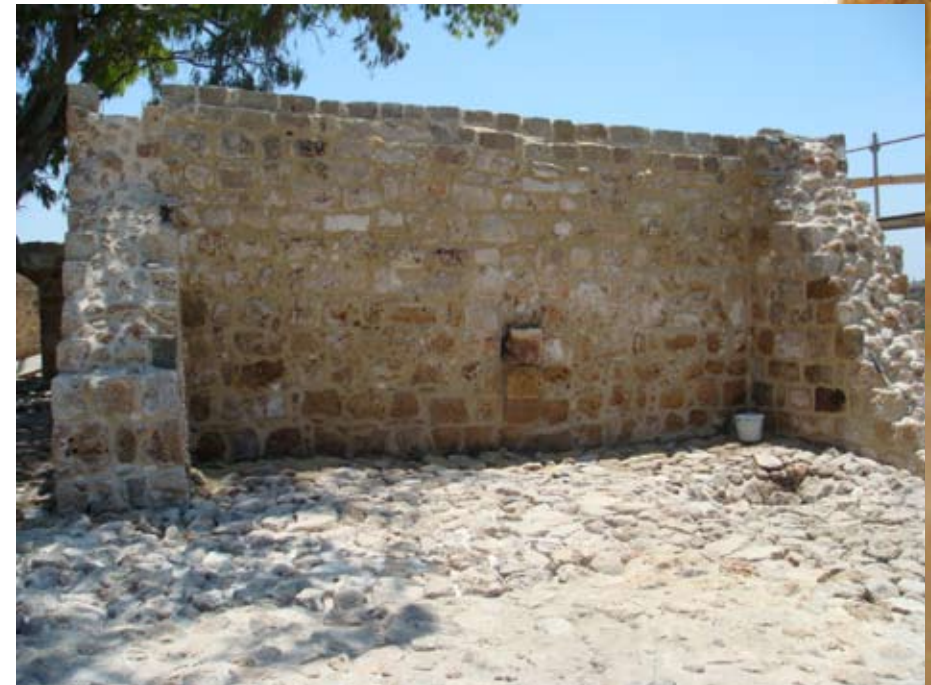
Since the abandonment of the original intended use of the site as flour mills, the Ruins at Ridván Garden were quickly overgrown with local weeds, bushes and trees.

The site had a secondary, later phase of life primarily as living quarters and shelter for grazing livestock. Once the roofs collapsed exposing wall tops and tree roots penetrated foundations and base of

walls the overall state of conservation deteriorated very rapidly. The phase where the core of the walls and the foundations are exposed to rain waters and plant growth is the time of most cumulative damage to the site. At a later phase an equilibrium is reached meaning that the collapsed portions of the ruins cover the still standing portions. This "natural" but unfortunate cover protects and supports, thus stopping further, rapid decay. When surveying the state of conservation at Ridván, this decay process is very clearly evident. The different monuments show different stages of decay but all show the same process and causes.

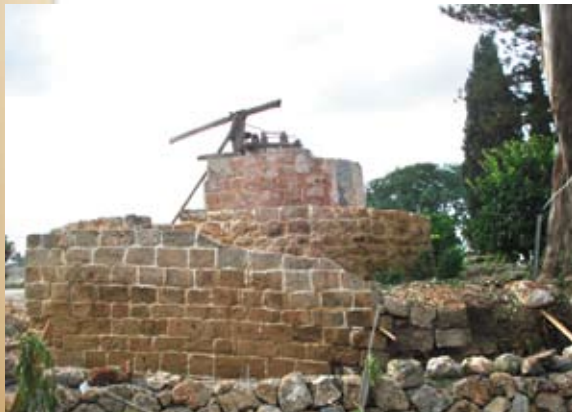
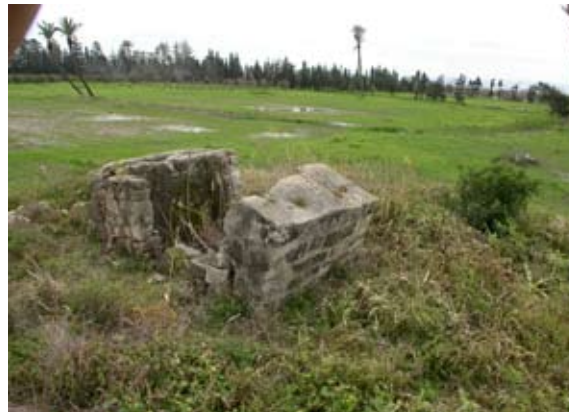
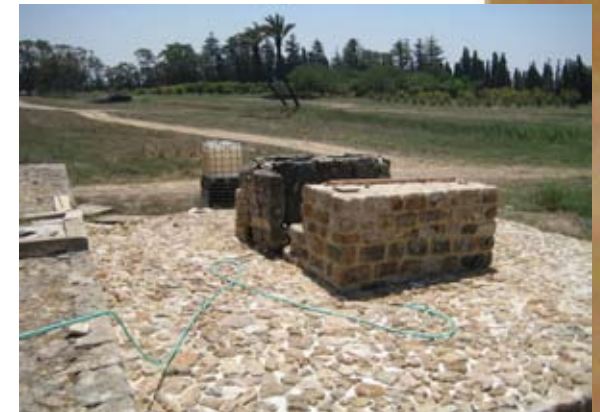
### The North Well:

The surrounding retaining wall showed areas of wall collapse which, in turn, caused the surrounding core, infill and flooring to collapse due to water penetration. There are many missing parts of the flooring and the retaining wall of the ramp, caused by penetration of small trees and bushes. All of the pointing, deep and shallow, were missing, which caused instability to the stones and to the wall as a whole.

The well complex suffered mainly from sinking on the south and west sides which caused major, constructive cracking to the structure. Other minor decays in the pointing and surrounding plasters were noted.

### The West Well and Pool:

The west pool is in a very stable condition of conservation regarding its grand size. In general there is a serious crack running length wise from

south to north. This crack has come through the layers of lime plaster and the built foundation and masonry of floor and walls. The stairs on the north side have sunk and detached from the pool's wall. There are few lacunas in the plaster and most of the plaster is covered with a coat of moss. Signs of vandalism are seen on the planks of marble on some of the outer walls and on the top of the south wall. There seems to be a mild degradation in the coping although in general it is intact but a little low in height to function properly.

The west well is in an overall very bad state of conservation. The low retaining wall has survived in only a few points. The flooring around the well is non-existent. The two components which make up the well have detached from each other and each piece has sunk and tilted considerably in opposite directions. All of the well and its vicinity are overgrown with weeds and bushes.

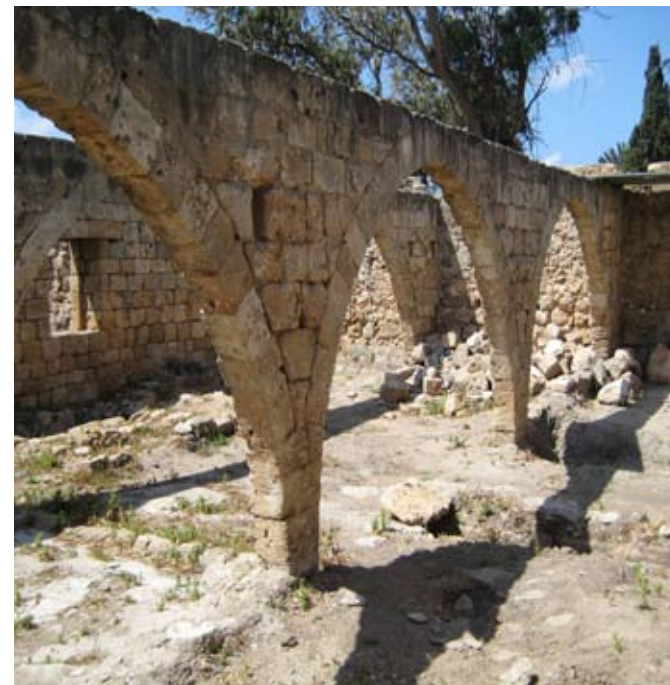
**Building 1:** The area of building 1 was completely overgrown with weeds, bushes and trees. There are no surrounding walls left standing other than the wall between building 1 and 2. This wall is severely damaged by large roots of the nearby Eucalyptus tree and is showing signs of bulging, departing of walls from core and is in immediate danger of collapse. Of the three sub floor canals, the east one is completely blocked and was not excavated. Its outlet vault on the south side was completely destroyed. The other two canals were excavated and have good amount of original plaster.

**Buildings 2, 3 and 4:** Although all three buildings were found in differing state of conservation, all revealed the same decay process and causes as mentioned above for building 1.

**Building 2:** This building comprises of two rooms. The north and west walls were in a dangerous state of conservation and very near collapse. The west room, being the smaller of the two had a major deformation of the west wall. As mentioned, this wall separated buildings 1 and 2. The cause for the bulging and deep cracking was the roots of the close by Eucalyptus tree. The main, large roots lifted the foundations upwards causing major cracking which opened the wall from both sides allowing rainwater to easily penetrate and wash out the core's earth-lime mortar. As a result of this problem over the years the wall was in great danger of collapse, similar to the east wall in building 3.

The north wall hid an entrance which was found at the beginning of the conservation works and decided to be rebuilt. Both to the east and west of the new opening great voids were found in the core of the wall which managed to survive to a height of ~3 metres.

All wooden window sills/beams facing south were rotten or missing. An arch supporting the roof beams remained standing although the supporting walls from east and west were missing or leaning sharply south causing great instability to the arch. Generally most of the deep and shallow pointing was missing as well as the base layer of stone of the floor.

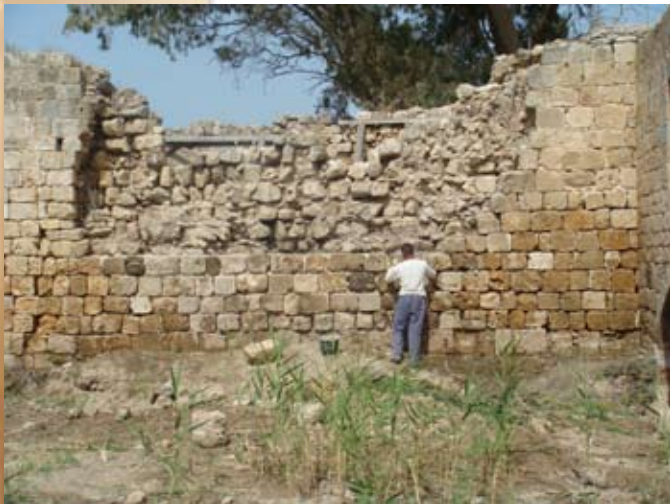
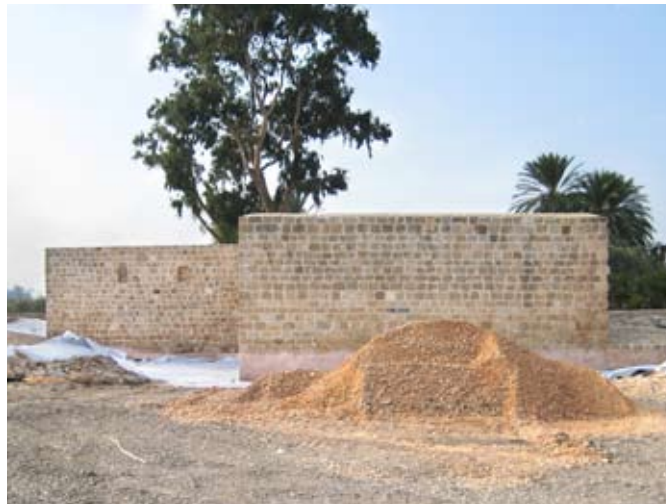
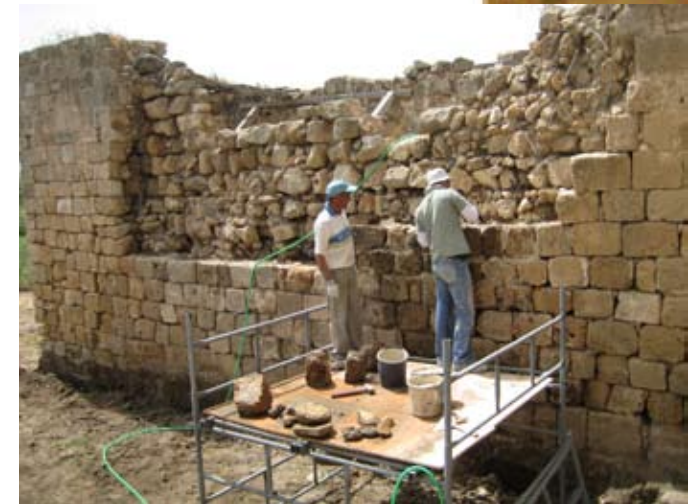
**Building 3:** This building comprises of one large room with a general stable state of conservation besides the eastern wall. The eastern wall, which reaches a height of more than 5 metres on the outer side, suffered great damage over the years and as mentioned was in great risk of collapse. Washing out of the wall's coping allowed a small tree to grow and send its long roots into the wall's core. This caused a slow process of detachment of the outer shell of the wall from the core. Eventually the outer shell collapsed leaving the earth/lime core exposed and eroded and leaving the inner shell of the wall bare and at great risk of collapse. A set of three arches as construction for the roof logs survived in stable condition. Wooden window beams were rotted and needed replacement. All floor bedding, pointing, plasters and coping were generally missing or in a state of decay.

**Building 4:** This structure survived in the best state as compared to all other structures of the flour mills. It is important to mention the west wall of the structure as being built of an outer shell and only a thick, rough, small, thin stones embedded lime plaster. Although the fragile make of the wall it showed no major constructive cracks. Although this building was constructed over 4 canals and its south wall projected over 5 metres high it showed no signs of constructive damage or problems. This structure was chosen for full reconstruction. As in the other 3 buildings also here the pointing, plasters, coping and floor bedding were missing or damaged.
