Boustanai №3

JERUSALEM

Conservation of the historic facade

Final
Conservation
Report

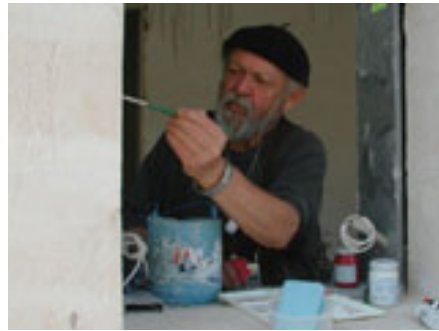
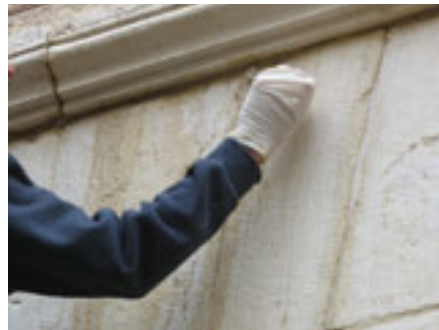
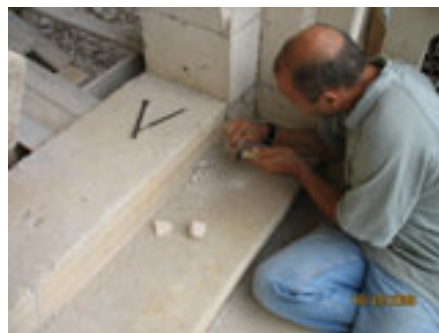
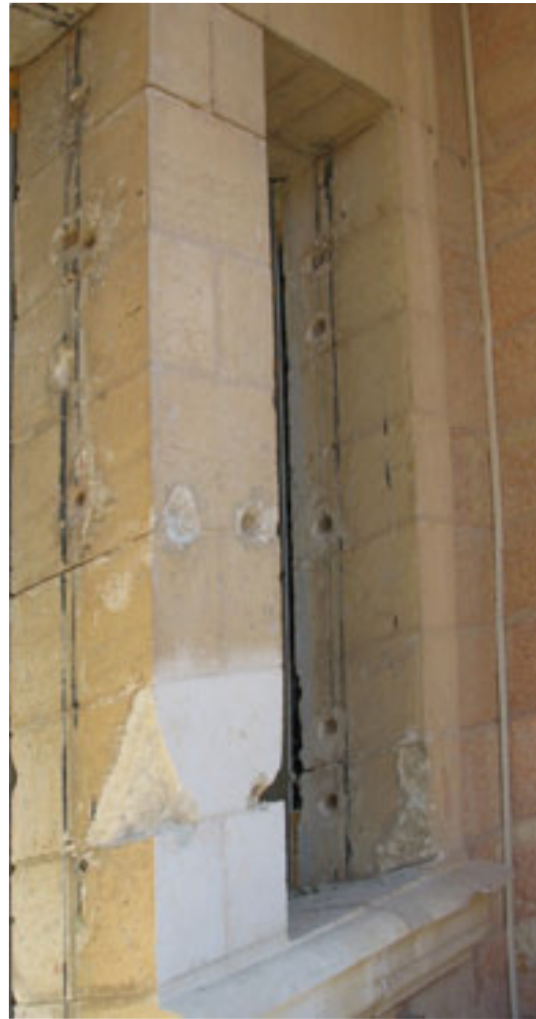
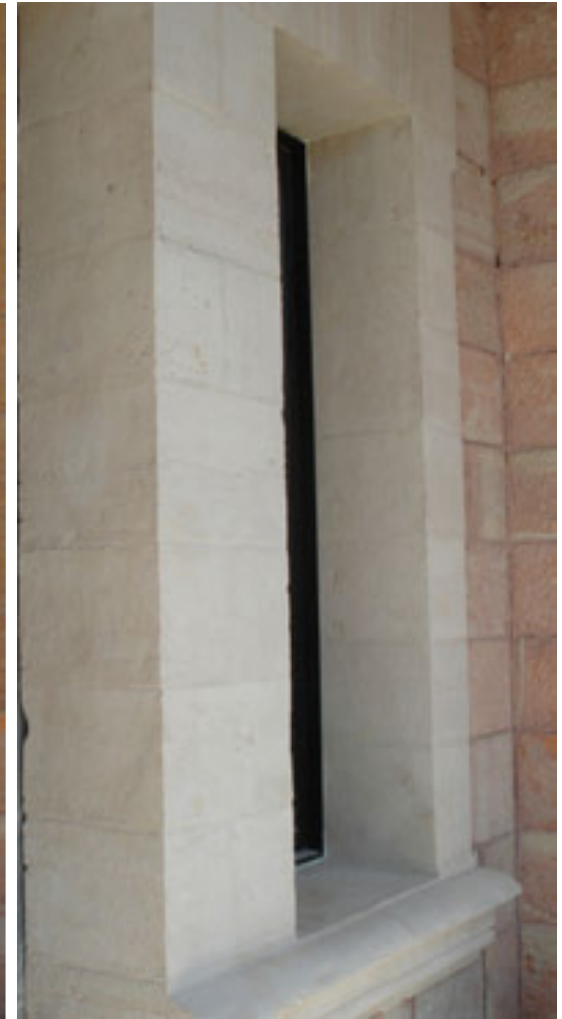
Conservators clean the historic stone with much finer and delicate techniques such as pH safe compressions and low pressure, basalt sand or PVC shreds system.

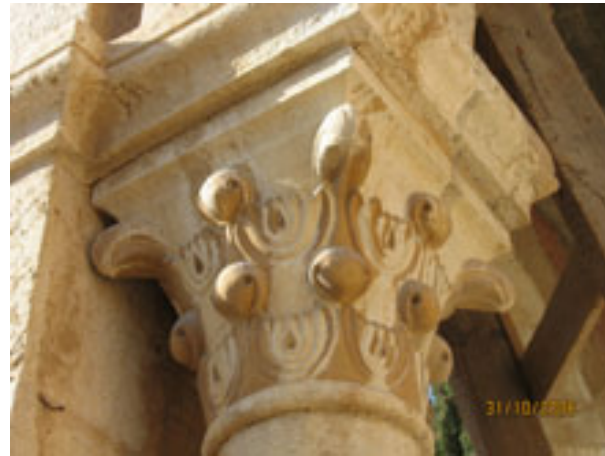
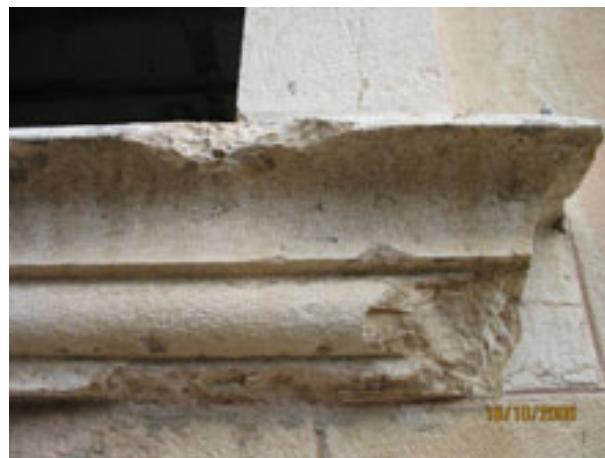
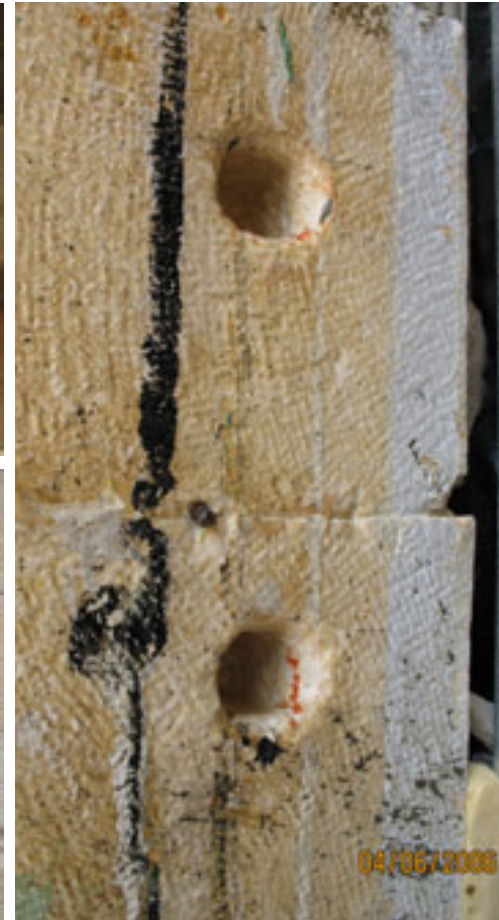
Observation of stone problems on site which required conservation treatment:

- Soft stone deterioration
- Deep penetrating holes
- Shallow surface damage
- Stone cracks and movements
- Missing corners and ornamental pieces
- Damaging use of modern cement for hole filling and missing pieces
- Old and modern (numbers) oil base paint on delicate, porous limestone
- Rust stains
- Surface dust and pollution encrustation on all historical façade

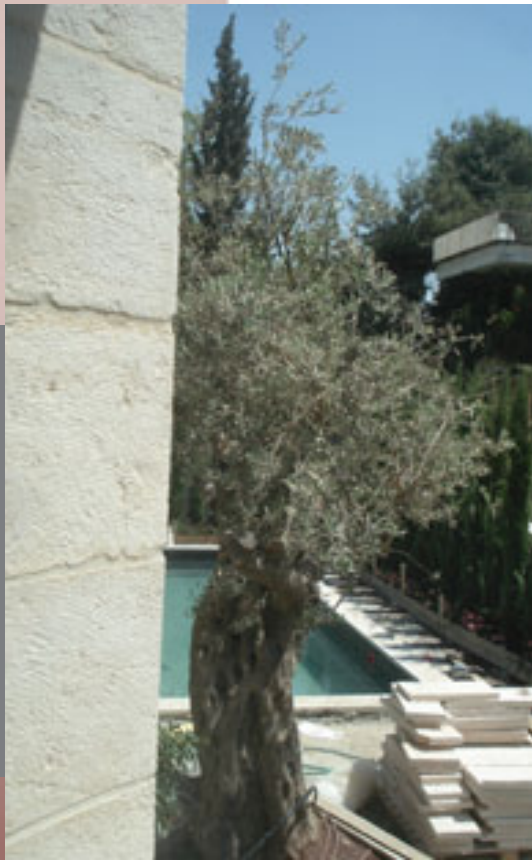
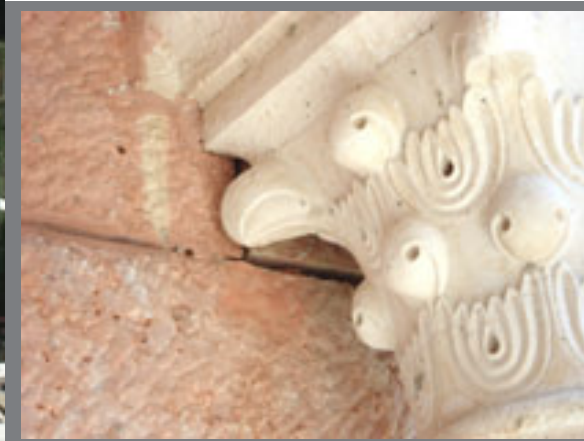
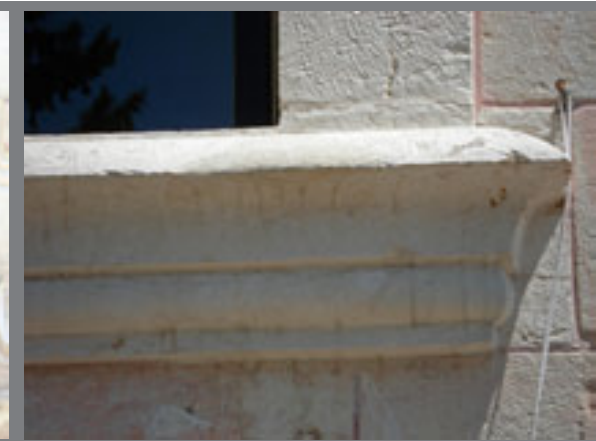
Conservation treatments made on site:

- Dismantling of all modern cement interventions on façade and soft stone decoration including on ornamental restorations
- Cleaning of encrustations from historical façade using a very fine basalt sand and low pressure cleaning system

- Cleaning of cement remnants and stains on new built and historical façade using the same fine sand-low pressure system
- Complete cleaning of all white, soft stone in windows, doorways, latticework, columns, capitals, cornice, gateway and staircases from stains, rust marks, old and new oil paint, cement interventions and encrustations using a very low pressure system with PVC shreds or an extra fine basalt sand

- Training and supervising the pointing material and work made by contractor
- Consolidation with lime mortars of all deteriorating limestone
- Treatment and cleaning of all lichens and biological growth on stone façade

- Filling with compatible lime mortars all cracks and shallow stone damage, eliminating visual differences between original stone and new repair
- Two stage fill of deep holes using same technique as for cracks

- Build up restoration of all missing corners and ornamental cornice, sill and capital pieces using compatible lime mortars, pinning technology and elimination of visual difference between original stone and new repair

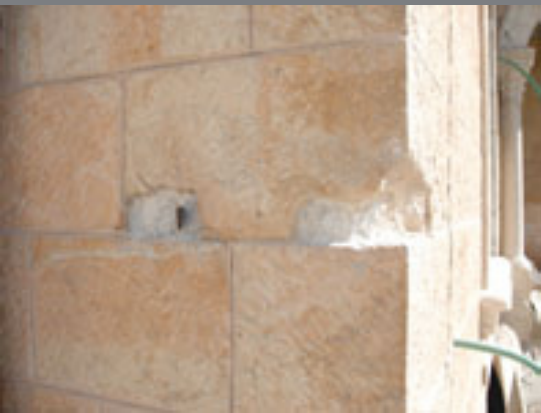
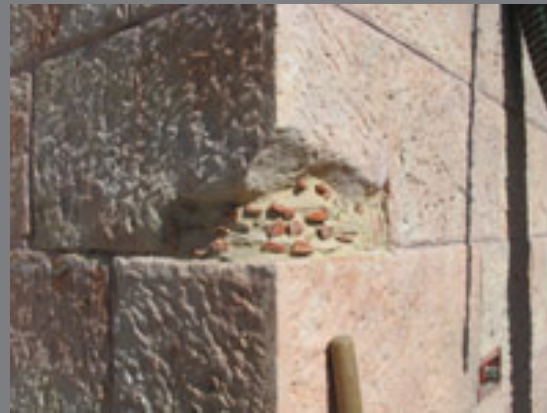
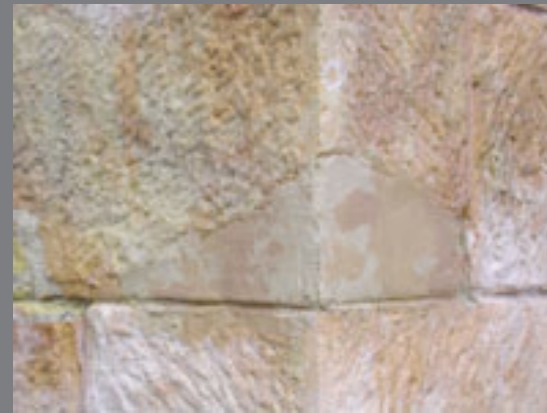
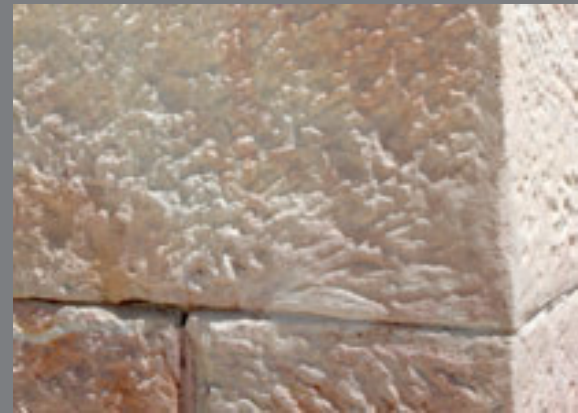
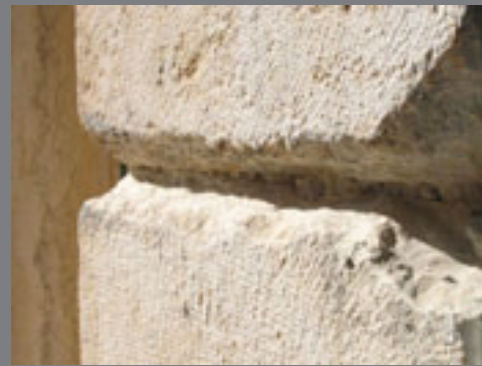
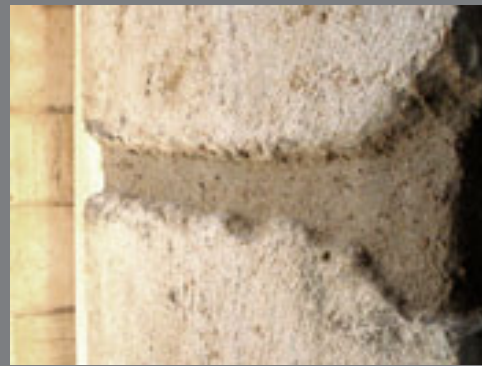
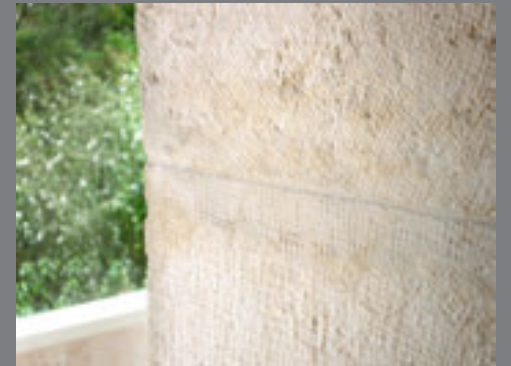
Original architectural elements which were treated by conservation:

- The entire historical, red-yellow stone façade
- Seventeen stone window frames including ornamental sills
- Three stone door frames
- Twenty-two metres of ornamental stone latticework
- Ten stone columns
- Ten detailed, Accantus stone capitals
- Stone cornice around all historical façade
- Five outside, stone staircases
- Entry gateway with surrounding walls and coping stone
