# Ridván Garden

Conservation of the historic monuments Akko

Final  
Conservation  
Report

Bahá'í World Centre  
Northern Development Projects  
April-November 2008

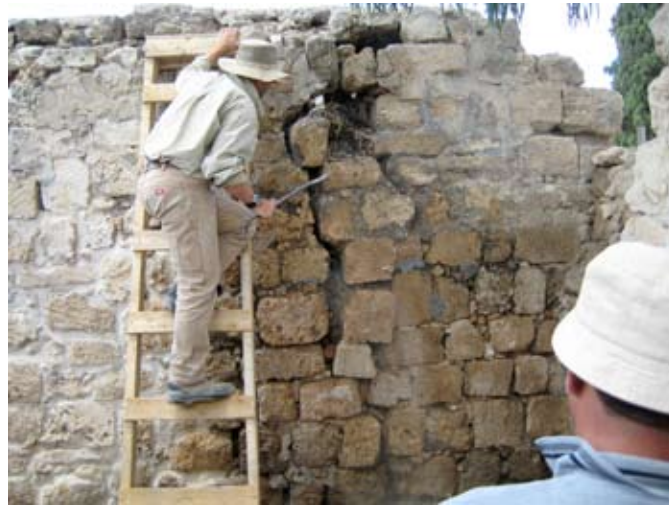
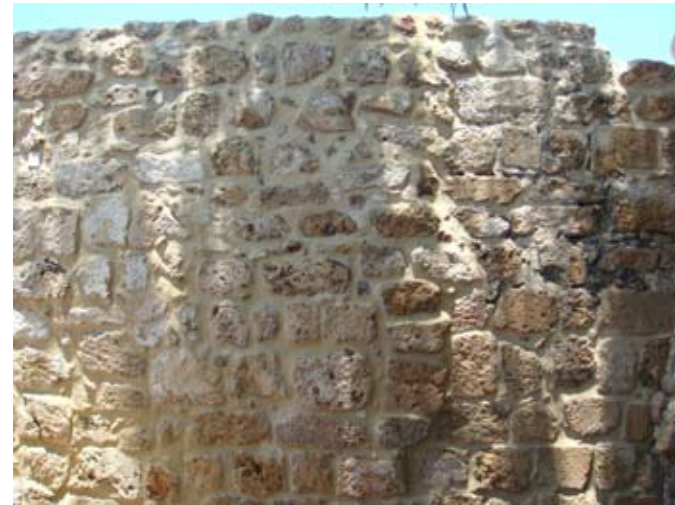
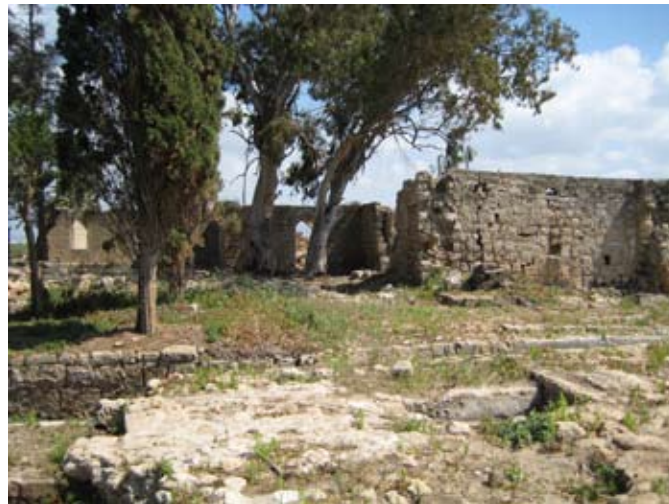
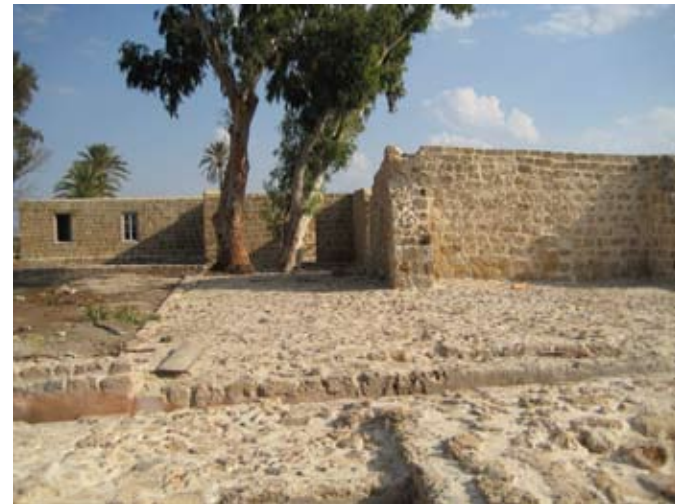
### Phase I- Preparation of Site:

Camp set-up; cleaning of ruins; materials and architecture study.

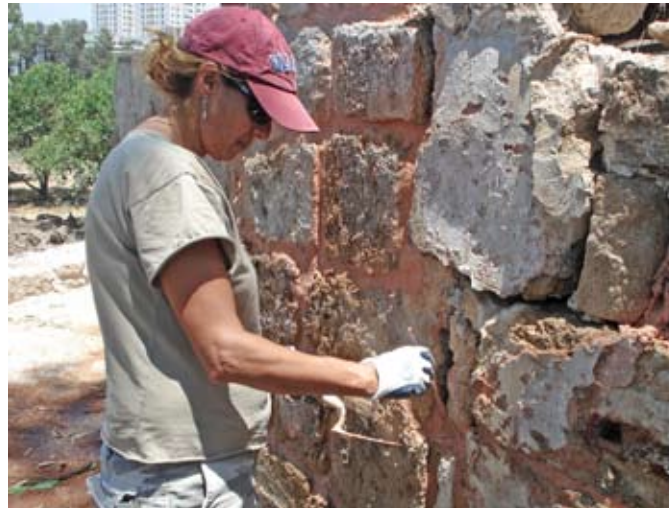
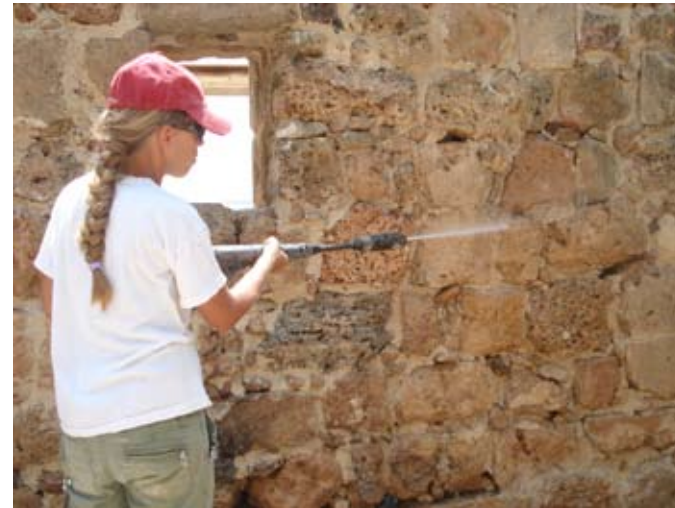
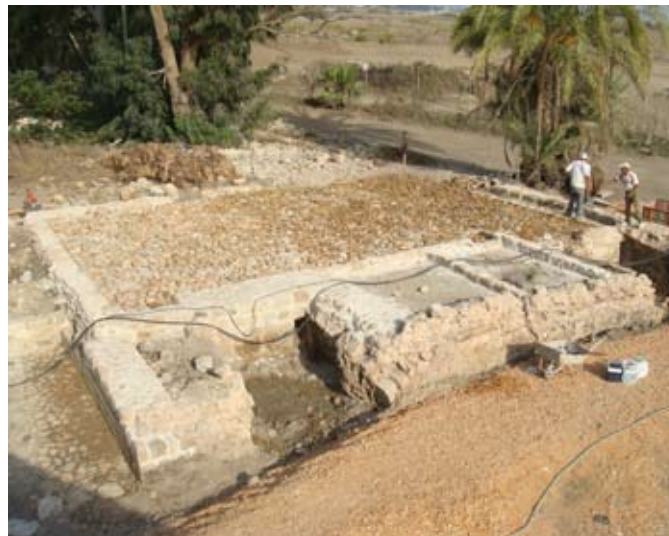
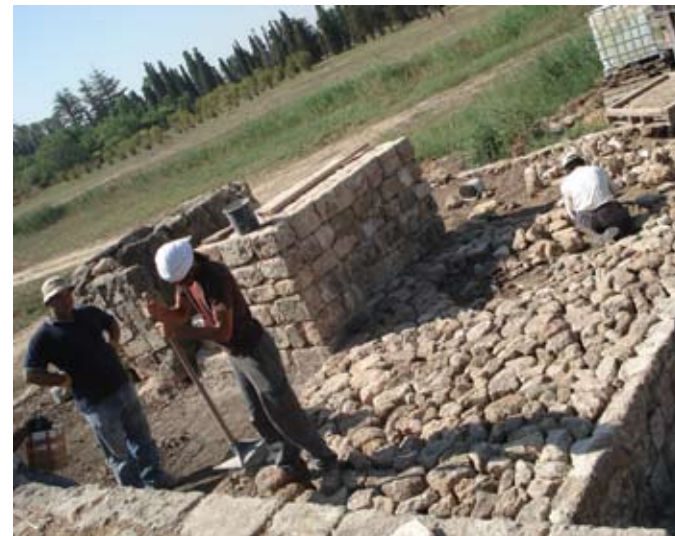
### Phase 2 - Stabilisation of Site:

Repacking of exposed wall core; deep joint pointing; filling of wall cracks; rebuilding of dangerous missing stone and courses; supports for arches and vaults; dismantling of Garden Gate; stabilisation works at North and West Wells.

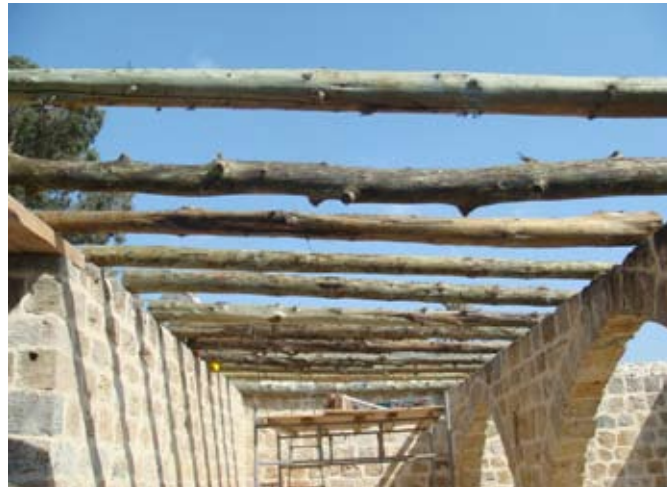
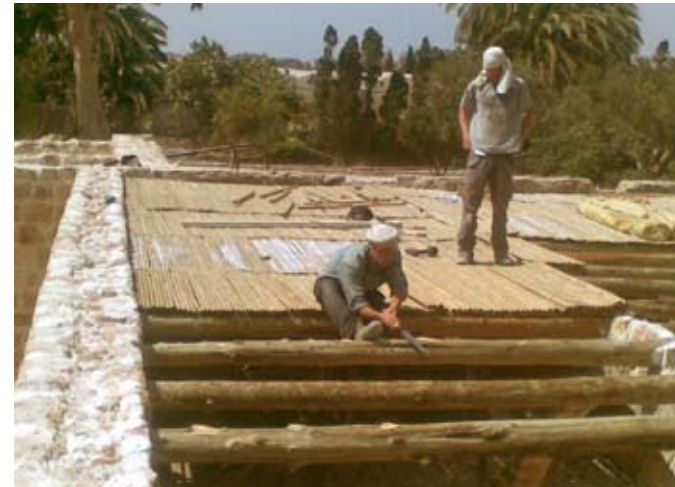
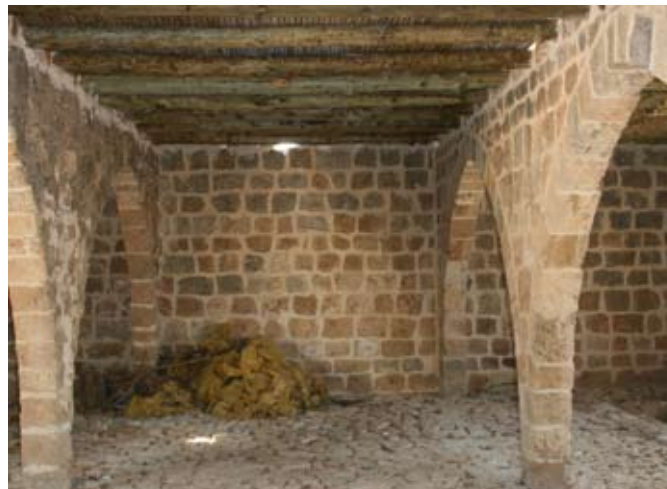
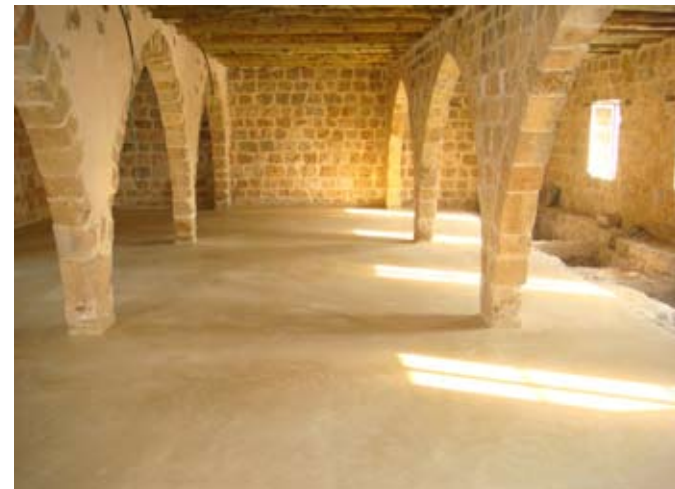
### Phase 3 – Reconstruction:

Rebuild of all walls; coping of wall tops; flooring; base and final coats of plaster of walls, canals, pools; rebuild of Garden Gate; roof and floor of building 4.

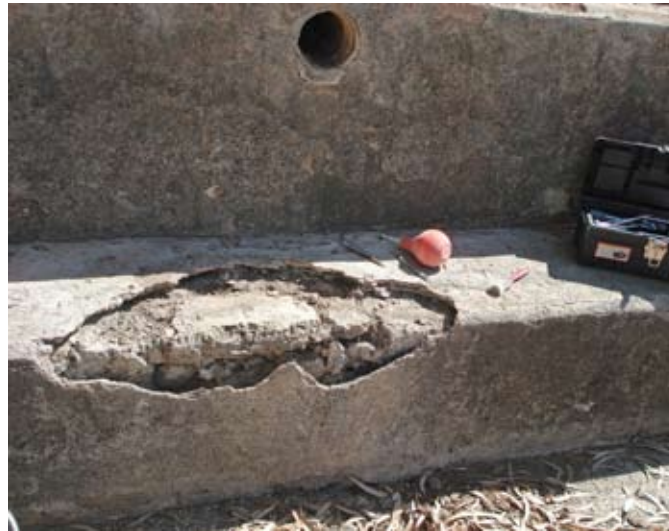
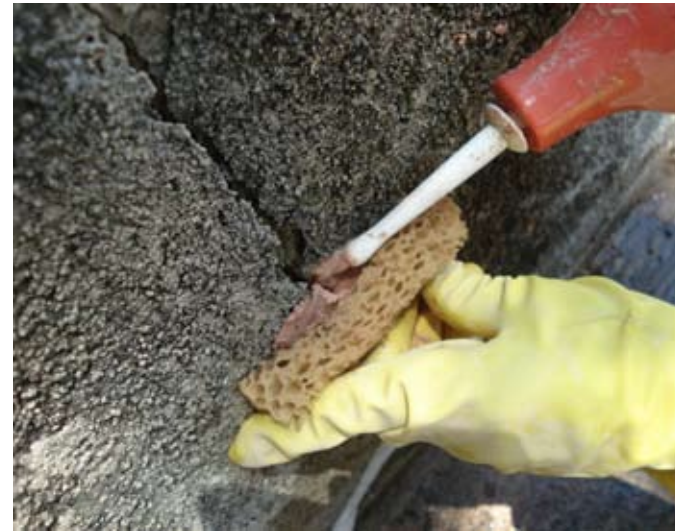
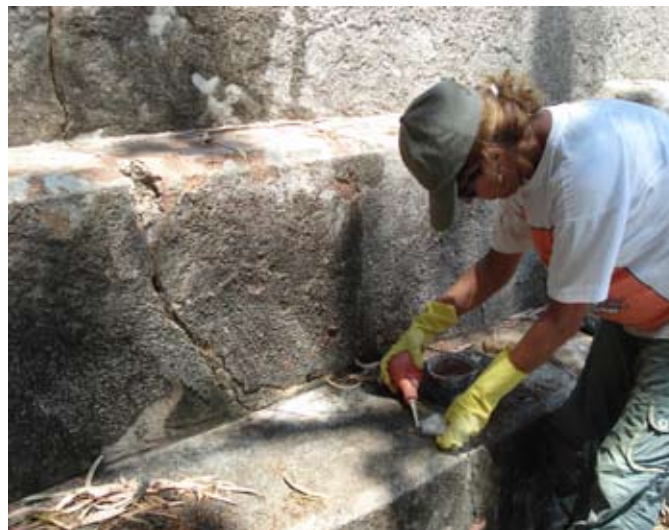
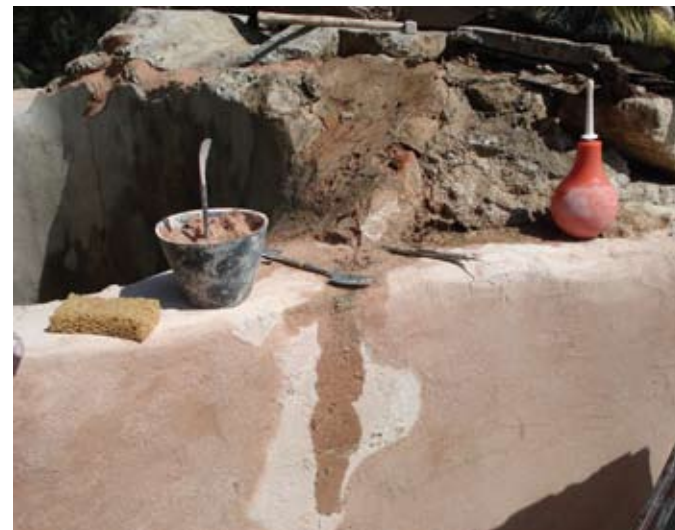
### Phase 4 – Conservation:

North and West wells; West pool; flour bins; existing plasters; fine pointing.
